CASE STUDY

Management of a horizontal root fracture with a Titanium Trauma Splint

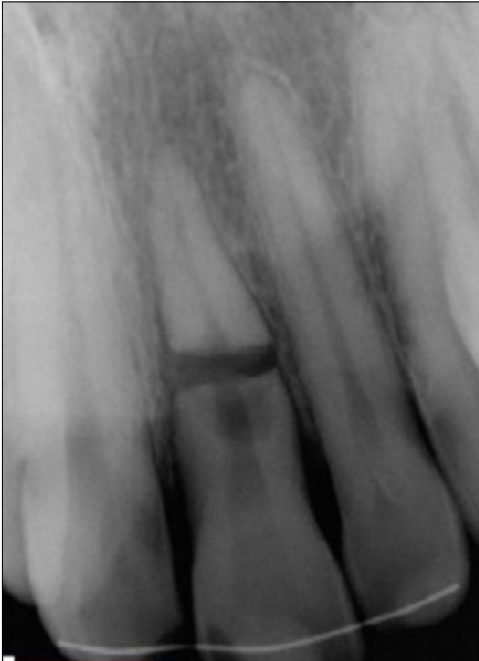
Figure 1: Conventional radiograph of an intra-alveolar fracture. A radiolucent area is visible beneath the fracture surface in the cervical fragment

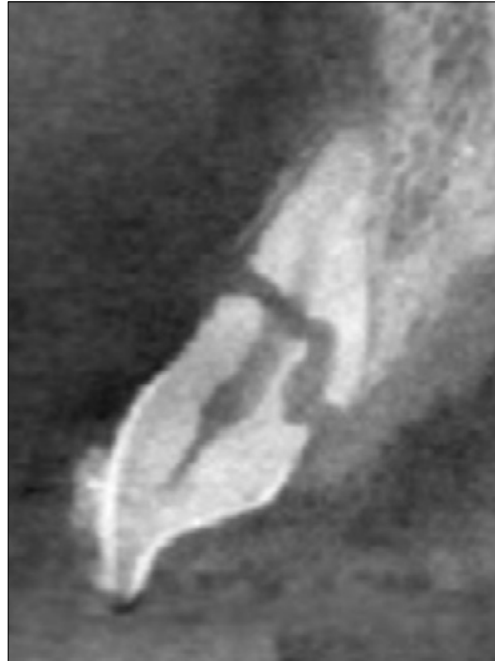
Figure 2: The same tooth, but a sagittal section of the CBCT

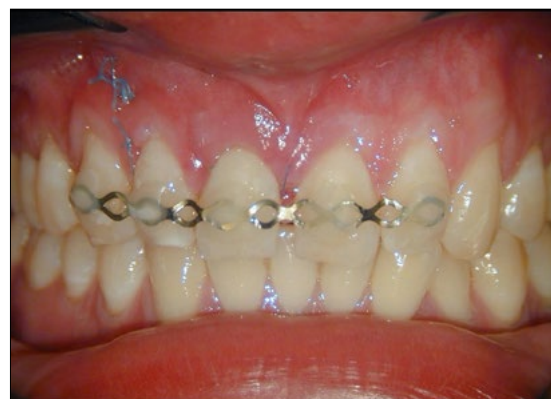
Figure 3: Titanium Trauma Splint applied to the maxillary front teeth

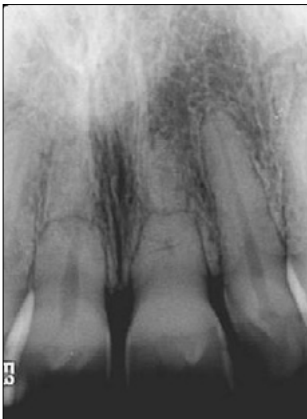
Figure 4: Radiograph of intra-alveolar fractures in 11 and 21 caused by an accident 25 years earlier. The patient is completely asymptomatic.

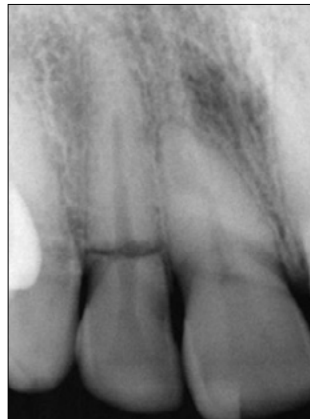
Figure 5: This intra-alveolar fracture in the 12 was caused by an accident five years ago. The tooth is slightly mobile, but functional and responds positively to pulp testing.

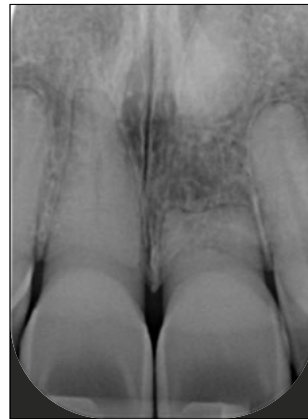
Figure 6: Nineteen-year-old root fracture. Both fragments are calcified and show surface resorption. The coronal fragment has undergone normal eruption, while the apical fragment has remained behind

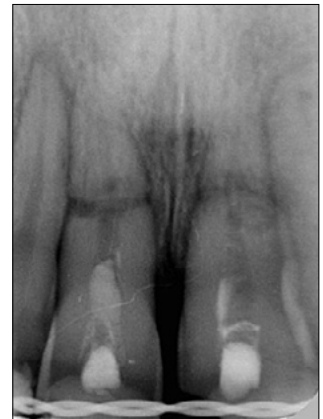
Figure 7: The pulp in coronal fragments of 11 and 21 has become necrotic, and granulation tissue is visible between the fracture surfaces.

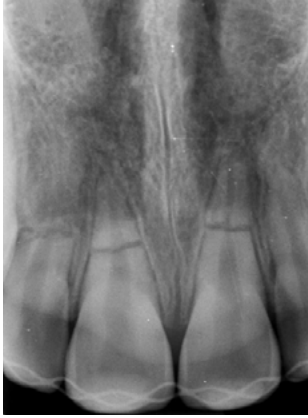
Figure 18: Post-operative radiograph showing that the space between the fracture surfaces has decreased

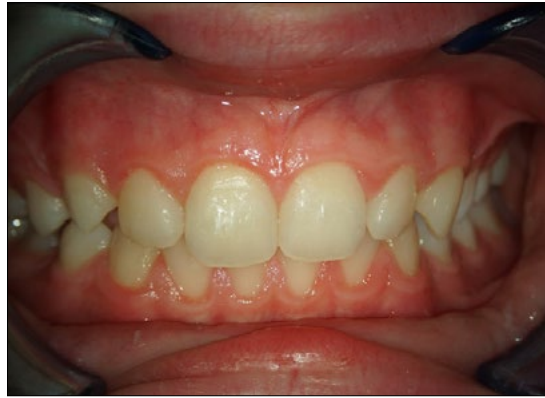
Figure 19: After removal of the splint

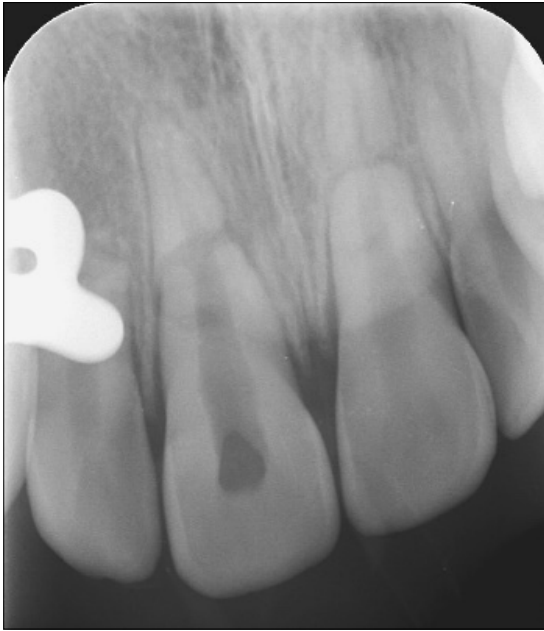
Figure 20: Pre-operative radiograph of tooth 11 after the patient became symptomatic
